2017 Hurricane Harvey Deployment
Arkema Facility Response
8/31/2017 1:45:27 PM

***2017 ASPECT Preliminary Report
Arkema Plant Response
Crosby, TX***

***August 31, 2017
0600 hrs to 1300 hrs***

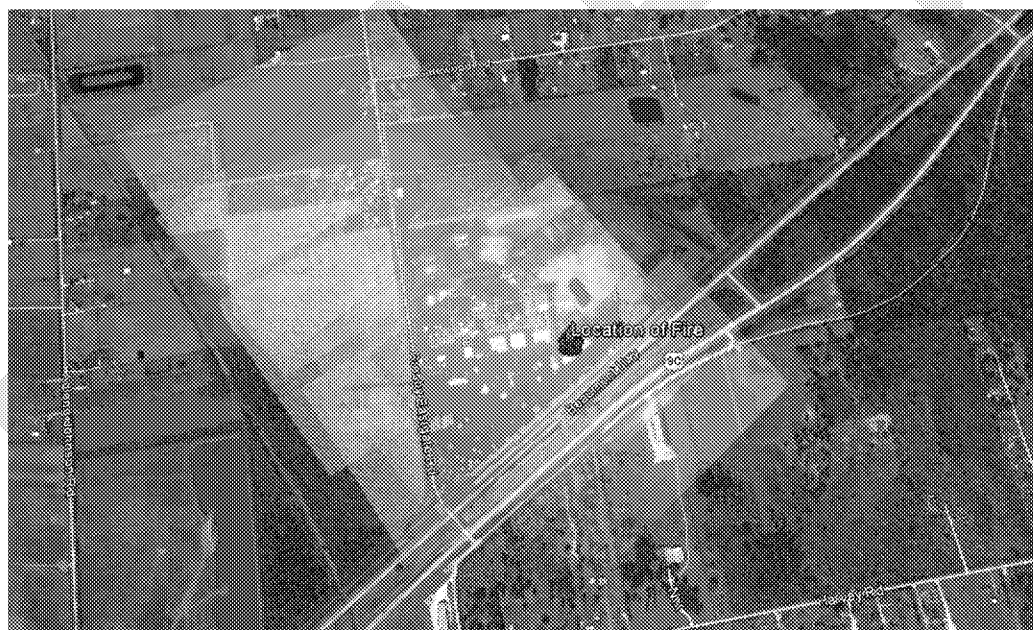
Figures 2 & 3 show a visible image of the facility with no observed plume and the flight path highlighted when IR sensors were active.

Figure 2: Low resolution aerial images pulled from the aircraft while in flight over the facility, 30 August 2017 at about 0730 hrs CST.

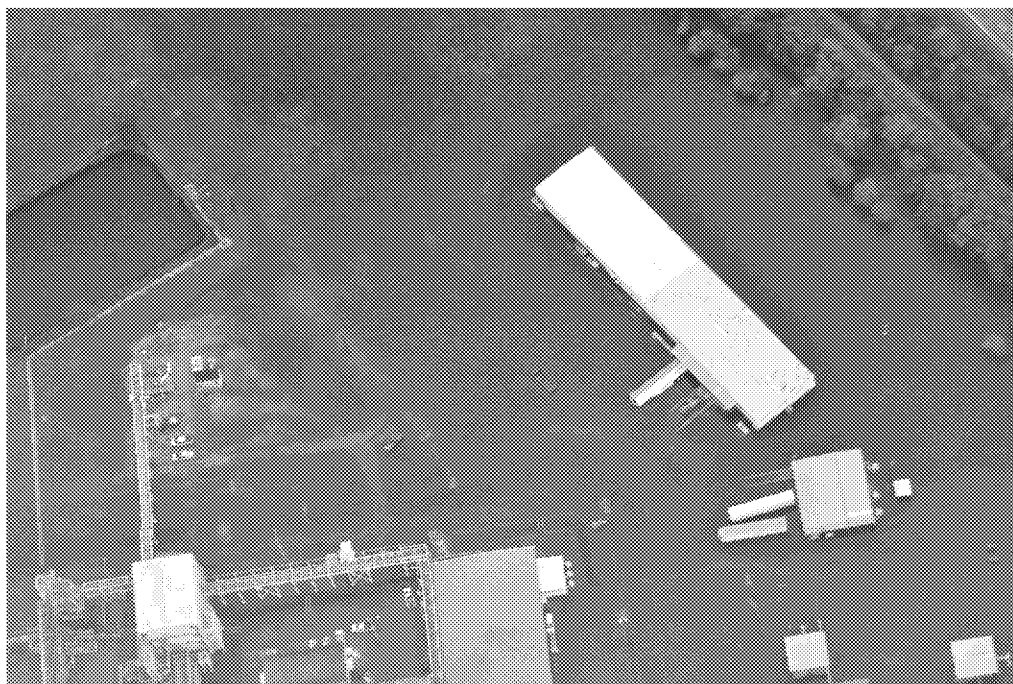
Figure 3: Oblique photo prior to explosion/fire on 30 August 2017.

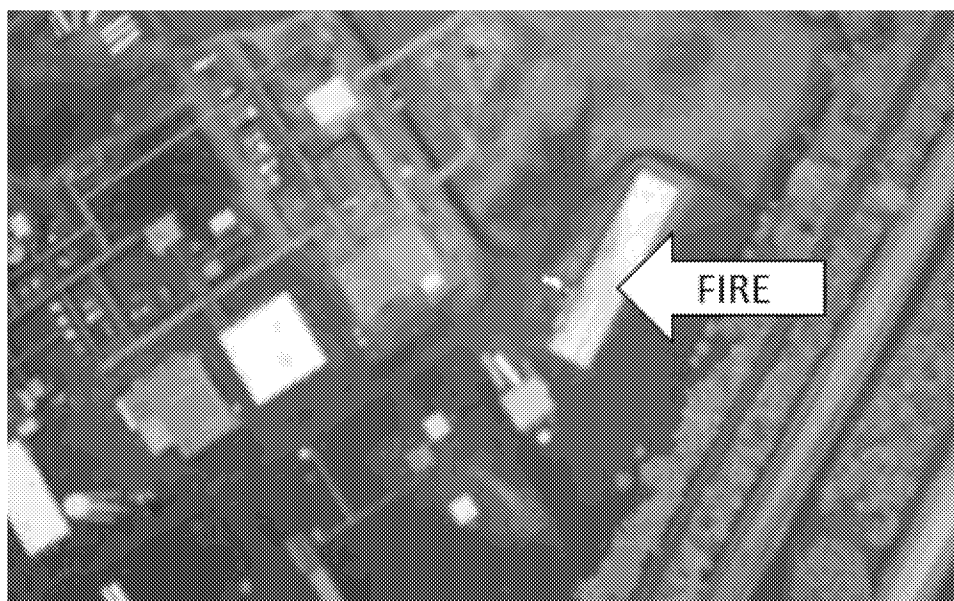
High-resolution aerial photos provide downward view of the area. Figure 5 has been enhanced due to poor visual conditions when the aircraft arrived on site. Foggy weather combined with low light conditions is reflected in this image.

Figure 5: Aerial photo over the site captured during the morning flight on 31 August 2017.

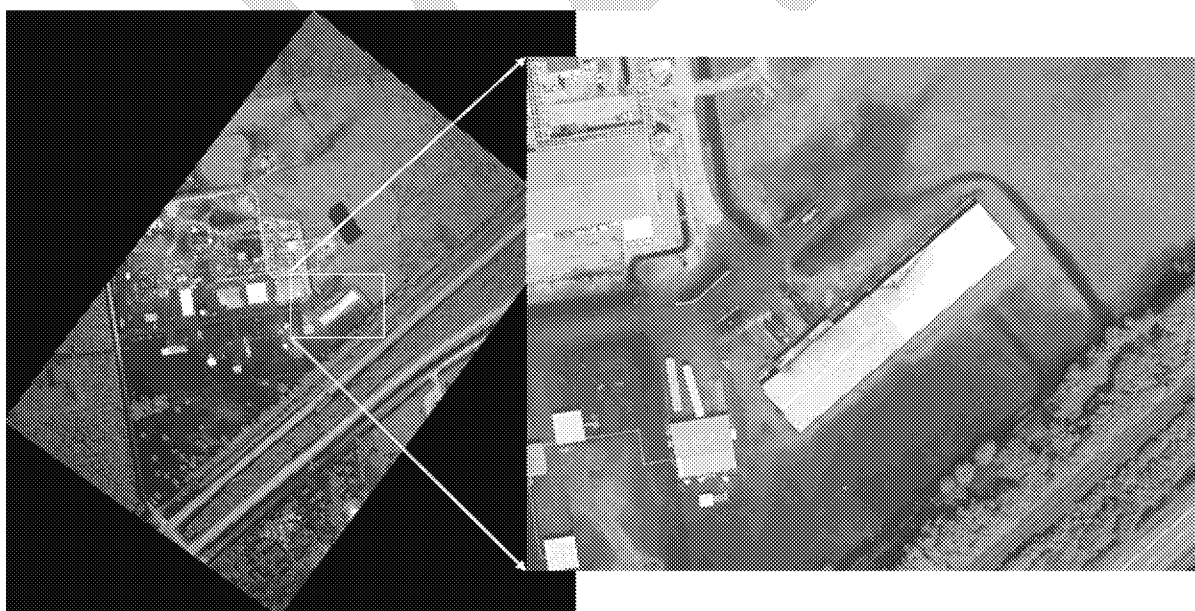
Figure 6: Low resolution aerial image retrieved from the aircraft during the afternoon sortie, approximately 1335 hrs. A copy of the entire image will be provided in an email. A portion of the photo was enlarged to show the affected building.

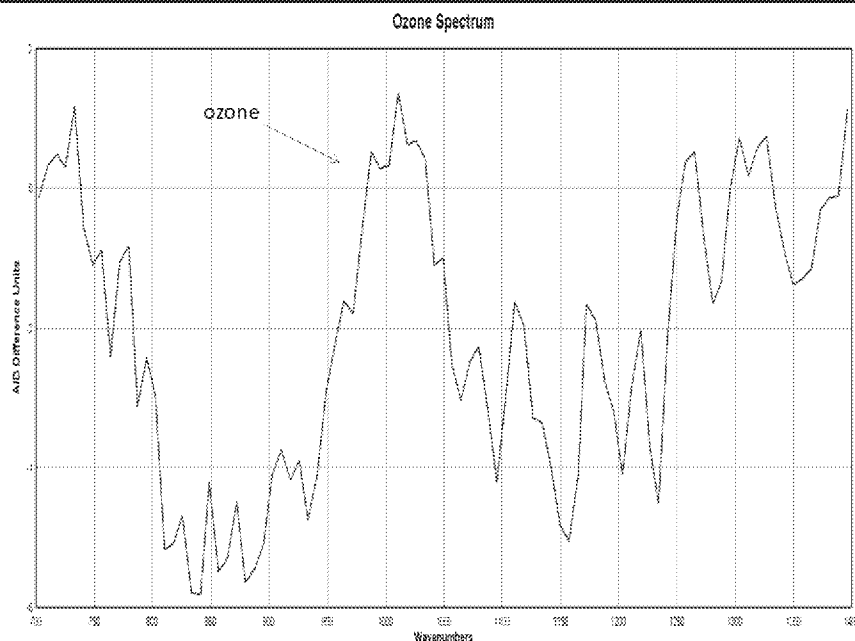
Figure 8: Passive (remotely detected at 2,800 ft AGL) FTIR spectra showing ozone, a commonly occurring air pollutant. This confirms that the instrument was operating properly.
